Efficiency Tests on Ludvika Hydropower Station

By Tommy Hjort, Cervus Power AB, Sweden

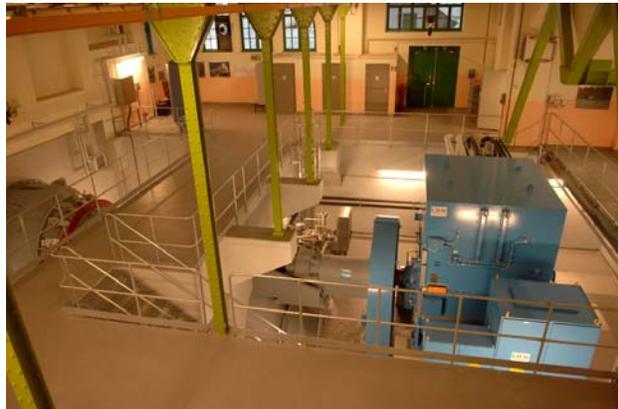
Figure 2. Power house interior

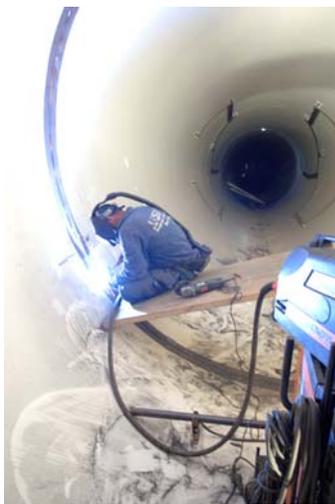
Figure 3. Sensor installation beyond welder

It is always very simplifying and cost-effective to do the thinking very early in a project. Thus while in horizontal position at the work shop and before surface treatment one penstock section, $L = 17 \text{ m}$ and $\text{Ø} = 3.75 \text{ m}$, was fitted with welded supports for the Accusonic sensors and a handhole for associate cabling. After surface treatment the sensors were installed and also the protective sheet metal cable covers. Thereby undamaged surface treatment was obtained and the installation took place in short time due to the short access distance of less than 8.5 m from either end. As to assure high accuracy for the overall efficiency measurements the switchgear current and potential transformers as well as the race-water and tail-water level pressure sensors were specified early and accordingly. Also the flow-sensor penstock section was later installed as to assure more than 10 diameters straight penstock ahead of and 5 diameters after the location of the sensors.

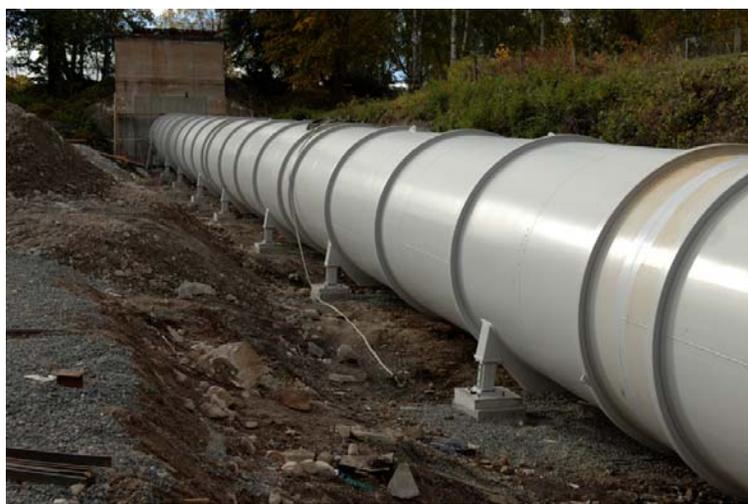
Figure 4. Straight penstock down-stream surge chamber
